# AI-Assisted Property Condition Report

| Report ID | SP-SAMPLE-0 |
| Inspection Type | Move-In Inspection |
| Property | 1492 Columbus Road |

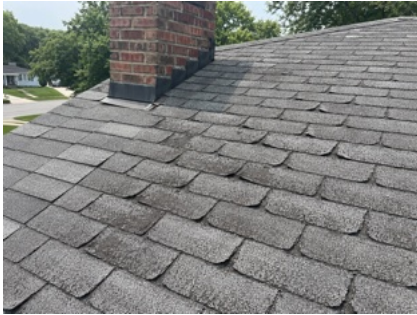
Uploaded: June 2, 2026 at 6:39 PM | Note: Roof slope — south elevation | Confidence: high

| Area | Issue Type | Severity | AI Description | User Status |
|---|---|---|---|---|
| Roof | Asphalt shingles — granule loss and cupping | Moderate | Multiple shingles on the south slope show significant granule loss and upward cupping at edges, indicating end-of-service-life condition. Roof estimated 18–22 years old. Replacement recommended within 2–3 years. No active leaks detected at time of inspection. | Confirmed |
| Roof | Chimney flashing — partial separation | Moderate | Step flashing at the chimney base shows partial separation at the front transition. Risk of water infiltration during heavy rainfall. Re-caulking and flashing repair required. | Confirmed |

Multiple shingles on the south slope show significant granule loss and upward cupping at edges, indicating end-of-service-life condition. Roof estimated 18–22 years old. Replacement recommended within 2–3 years. No active leaks detected at time of inspection.

· Moderate: Step flashing at the chimney base shows partial separation at the front transition. Risk of water infiltration during heavy rainfall. Re-caulking and flashing repair required.

Clean and re-photo before final acceptance.

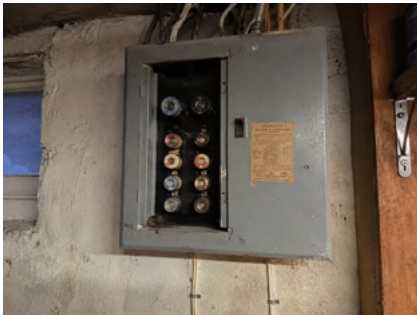
Uploaded: June 2, 2026 at 6:39 PM | Note: Panel box overview | Confidence: high

| Electrical Panel | 60-amp fuse panel — recommend upgrade <b>Severe</b> | Existing 60-amp fuse-based service panel is original to the 1958 build. Insufficient capacity for modern electrical loads. Insurance providers may require upgrade to obtain coverage. Recommend replacement with 200-amp breaker panel. | Confirmed |

Existing 60-amp fuse-based service panel is original to the 1958 build. Insufficient capacity for modern electrical loads. Insurance providers may require upgrade to obtain coverage. Recommend replacement with 200-amp breaker panel.

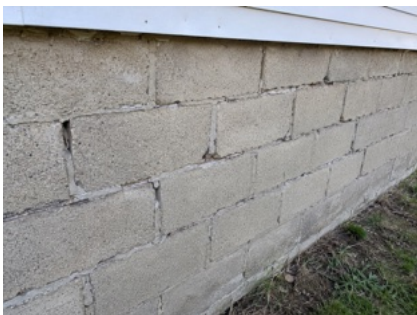
Uploaded: June 2, 2026 at 6:39 PM | Note: Foundation wall — east | Confidence: high

| Foundation | Mortar joint deterioration — east foundation wall <b>Minor</b> | Mortar joints on the east foundation wall show moderate erosion and crumbling at several locations. Common for homes of this age. Tuck-pointing repair recommended to prevent moisture penetration. | Confirmed |

Mortar joints on the east foundation wall show moderate erosion and crumbling at several locations. Common for homes of this age. Tuck-pointing repair recommended to prevent moisture penetration.

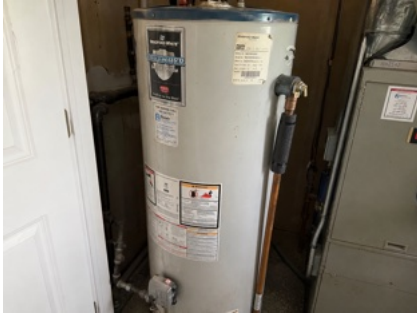
Uploaded: June 2, 2026 at 6:39 PM | Note: Main stack — drain condition | Confidence: high

| Plumbing | Water heater — near end of service life <b>Minor</b> | Hot water tank is dated 2012, placing it at 14 years of age. Industry standard service life is 10–12 years. No active failure observed at time of inspection but replacement should be budgeted. | Confirmed |

Hot water tank is dated 2012, placing it at 14 years of age. Industry standard service life is 10–12 years. No active failure observed at time of inspection but replacement should be budgeted.

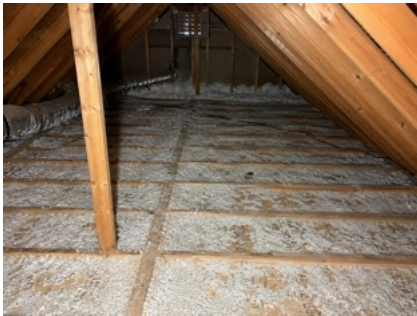
Uploaded: June 2, 2026 at 6:39 PM | Note: Attic insulation depth | Confidence: high

| Attic | Attic insulation below current standard <b>Minor</b> | Existing loose-fill insulation depth measures approximately R-18 in most areas, below the current Ontario Building Code recommendation of R-60 for new construction. Adding blown-in insulation would improve energy performance. | Confirmed |

Existing loose-fill insulation depth measures approximately R-18 in most areas, below the current Ontario Building Code recommendation of R-60 for new construction. Adding blown-in insulation would improve energy performance.
