# AI-Assisted Property Condition Report

| Report ID | SP-SAMPLE-0 |
| Inspection Type | Routine Inspection |
| Property | 400 King St W, Unit 1205 |

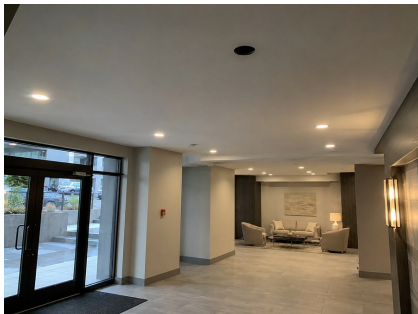
### Building Lobby

| Area | Issue Type | Severity | AI Description | User Status |
|---|---|---|---|---|
| Building Lobby | Recessed light out — lobby entrance | Minor | One recessed light fixture near the main entrance is non-functional. Bulb replacement or fixture inspection required. Affects lobby lighting uniformity. | Confirmed |

One recessed light fixture near the main entrance is non-functional. Bulb replacement or fixture inspection required. Affects lobby lighting uniformity.

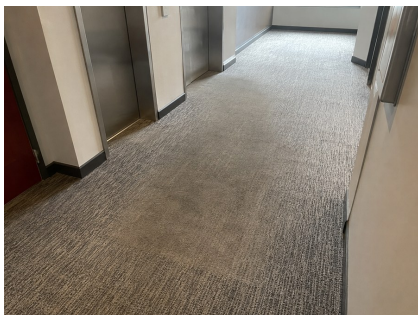
### 12th Floor Hallway

| Area | Issue Type | Severity | AI Description | User Status |
|---|---|---|---|---|
| 12th Floor Hallway | Hallway carpet — wear pattern at elevator | Minor | Noticeable carpet compression and fibre wear directly in front of the elevator doors, extending approximately 1.2 m into the hallway. Consistent with high foot-traffic. Plan for carpet replacement at next cycle. | Confirmed |

Noticeable carpet compression and fibre wear directly in front of the elevator doors, extending approximately 1.2 m into the hallway. Consistent with high foot-traffic. Plan for carpet replacement at next cycle.

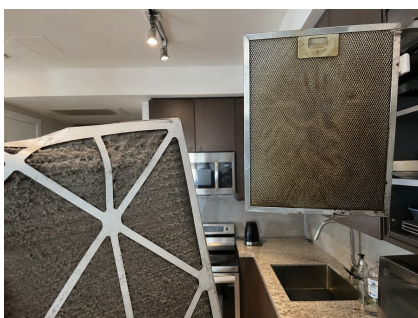
### Unit 1205 — Kitchen

| Unit 1205 —<br>Kitchen | HVAC filter — requires re-<br>placement | Moderate | HVAC filter is visibly clogged with dust accumulation. Filter has not been replaced within the standard 90-day cycle. Continued operation may reduce air quality and HVAC efficiency. | Confirmed |

HVAC filter is visibly clogged with dust accumulation. Filter has not been replaced within the standard 90-day cycle. Continued operation may reduce air quality and HVAC efficiency.

Clean and re-photo before final acceptance.

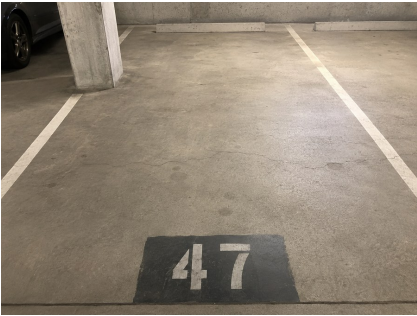
Uploaded: June 2, 2026 at 6:39 PM | Note: Parking stall surface | Confidence: high

| Parking Level B —<br>Stall 47 | Concrete surface cracking — parking level B | Minor | Hairline cracks observed across the surface of parking stall 47, extending approximately 80 cm in length. Appears consistent with normal concrete settling. Monitor at next inspection; no immediate structural concern. | Confirmed |

**AI condition note:**  
Hairline cracks observed across the surface of parking stall 47, extending approximately 80 cm in length. Appears consistent with normal concrete settling. Monitor at next inspection; no immediate structural concern.
