# AI-Assisted Property Condition Report

| Inspection Type | Routine Inspection |
| Property | 2245 Wellington Ave |
| Inspection Date | May 26, 2026 |

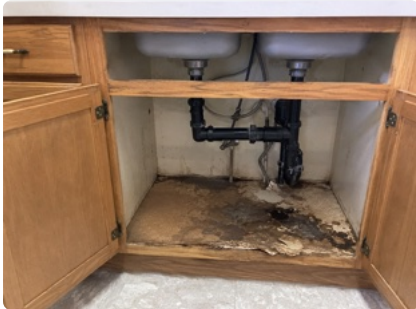
### Kitchen — Pre-Renovation

| Area | Issue Type | Severity | AI Description | User Status |
|---|---|---|---|---|
| Kitchen — Pre-Renovation | Pre-existing water damage at sink base | Moderate | Water-stained particle board visible at the base of the sink cabinet. Damage is pre-existing, not related to current renovation scope. Document for owner awareness before cabinet removal. | Confirmed |

Water-stained particle board visible at the base of the sink cabinet. Damage is pre-existing, not related to current renovation scope. Document for owner awareness before cabinet removal.

Clean and re-photo before final acceptance.

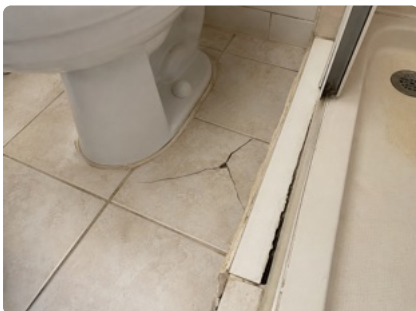
### Master Bathroom — Pre-Renovation

| Area | Issue Type | Severity | AI Description | User Status |
|---|---|---|---|---|
| Master Bathroom — Pre-Renovation | Cracked floor tile — pre-existing | Minor | Two ceramic floor tiles near the toilet base are cracked, likely from past impact. Noted here to confirm these cracks pre-date the renovation. Will be replaced as part of scope. | Confirmed |

Two ceramic floor tiles near the toilet base are cracked, likely from past impact. Noted here to confirm these cracks pre-date the renovation. Will be replaced as part of scope.

Marked as Minor issue · confirmed by inspector.

· Moderate: Shower pan grout shows significant deterioration and gaps at the perimeter seal. Potential water infiltration risk. Replacement included in renovation scope.

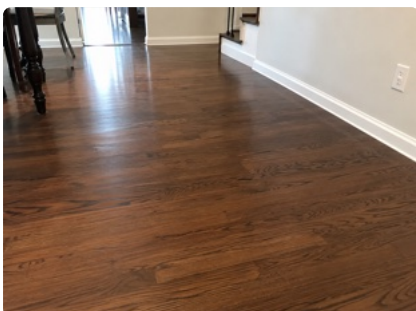
### Main Floor — Affected Zone

No visible damage detected in this area. Surfaces and fixtures appear in acceptable condition.

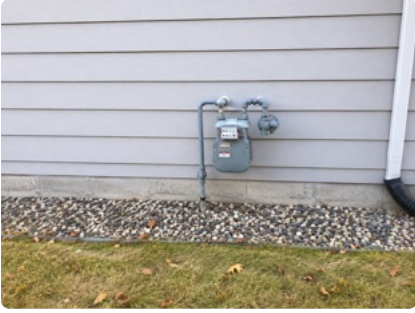
Uploaded: June 2, 2026 at 6:39 PM | Note: Gas meter access

No visible damage detected in this area. Surfaces and fixtures appear in acceptable condition.
