# AI-Assisted Property Condition Report

| Inspection Type | Move-Out Inspection |
| Property | 67 Elmwood Drive |
| Inspection Date | May 25, 2026 |

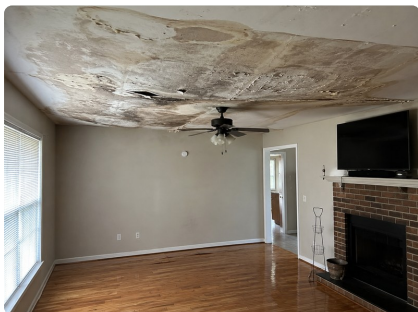
| Area | Issue Type | Severity | AI Description | User Status |
|---|---|---|---|---|
| Living Room | Ceiling water damage — extensive | Severe | Drywall ceiling shows active saturation across approximately 3.2 m × 2.1 m. Paint bubbling and joint tape separation visible. Structural integrity of ceiling assembly at risk. Immediate containment and drying required. | Confirmed |
| Living Room | Hardwood floor — water wicking and buckling | Severe | Hardwood floor boards along the north wall show visible upward buckling, consistent with water absorption from below. Moisture readings at 35% MC (dry standard: <12%). Full floor replacement likely required. | Confirmed |

Drywall ceiling shows active saturation across approximately 3.2 m × 2.1 m. Paint bubbling and joint tape separation visible. Structural integrity of ceiling assembly at risk. Immediate containment and drying required.

· Severe: Hardwood floor boards along the north wall show visible upward buckling, consistent with water absorption from below. Moisture readings at 35% MC (dry standard: <12%). Full floor replacement likely required.

Uploaded: June 2, 2026 at 6:39 PM | Note: Ceiling water damage — overview | Confidence: high

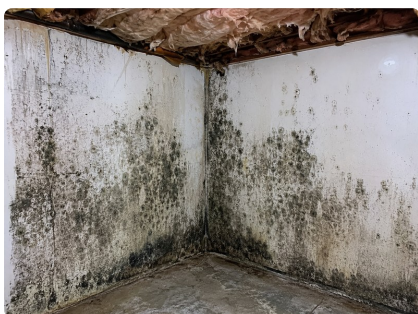
| Basement | Active mould growth — north and east walls | Severe | Black mould (suspected Stachybotrys or Aspergillus) identified on drywall surfaces of north and east basement walls over approximately 4.5 m². Musty odour present. Air quality testing and professional remediation required. Occupants must vacate affected areas. |
| Basement | Batt insulation — water saturated | Moderate | Fibreglass batt insulation in basement ceiling cavity is visibly saturated and sagging. Insulation must be removed and replaced. Area behind insulation should be inspected for mould. |

Black mould (suspected *Stachybotrys* or *Aspergillus*) identified on drywall surfaces of north and east basement walls over approximately 4.5 m². Musty odour present. Air quality testing and professional remediation required. Occupants must vacate affected areas.

· Moderate: Fibreglass batt insulation in basement ceiling cavity is visibly saturated and sagging. Insulation must be removed and replaced. Area behind insulation should be inspected for mould.

Uploaded: June 2, 2026 at 6:39 PM | Note: Mould growth — north wall | Confidence: high

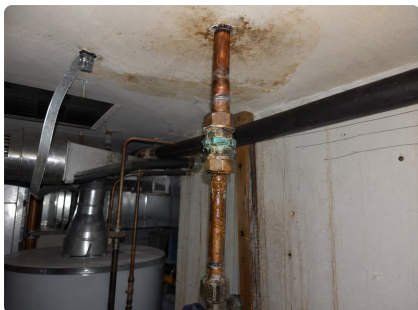
| Utility Room | Source — burst hot water supply line | Severe | 1/2" copper hot water supply line to the second floor bathroom has failed at a compression fitting, approximately 30 cm above the utility room ceiling. Failure mode consistent with fitting corrosion. Supply now shut off at main valve. Documented as source event for insurance claim. |

1/2" copper hot water supply line to the second floor bathroom has failed at a compression fitting, approximately 30 cm above the utility room ceiling. Failure mode consistent with fitting corrosion. Supply now shut off at main valve. Documented as source event for insurance claim.

Uploaded: June 2, 2026 at 6:39 PM | Note: Burst supply line — documented
