# AI-Assisted Property Condition Report

| Inspection Type | Move-In Inspection |
| Property | 789 Bloor St W, Unit 3 |
| Inspection Date | May 31, 2026 |

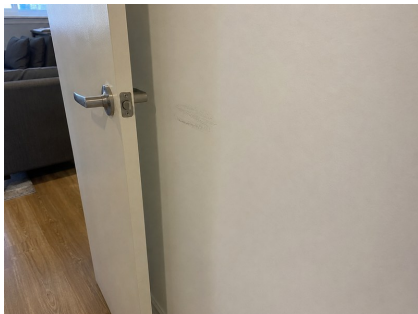
### Living Room

| Area | Issue Type | Severity | AI Description | User Status |
|---|---|---|---|---|
| Living Room | Wall scuff mark — behind door | Minor | Faint scuff mark approximately 15 cm × 8 cm on the wall directly behind the entrance door, consistent with door handle impact. Pre-existing. Photographed and documented on move-in day. | Confirmed |

Faint scuff mark approximately 15 cm × 8 cm on the wall directly behind the entrance door, consistent with door handle impact. Pre-existing. Photographed and documented on move-in day.

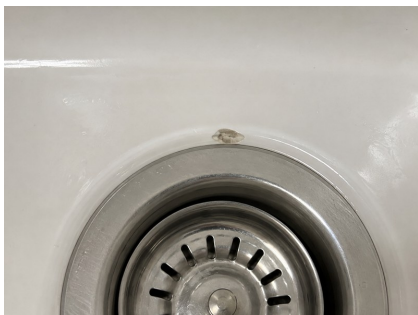
### Kitchen

| Area | Issue Type | Severity | AI Description | User Status |
|---|---|---|---|---|
| Kitchen | Porcelain sink — small chip at drain rim | Minor | Small chip in the porcelain glaze at the rear edge of the kitchen sink drain, approximately 1 cm in diameter. Chip is superficial and does not affect sink function. Documented as pre-existing on move-in date. | Confirmed |

Small chip in the porcelain glaze at the rear edge of the kitchen sink drain, approximately 1 cm in diameter. Chip is superficial and does not affect sink function. Documented as pre-existing on move-in date.

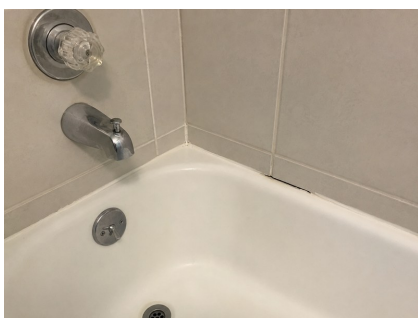
### Bathroom

| Bathroom | Caulk at tub edge — minorMinor gap | Small gap in the caulk line at the tub-to-tile transition near the tap end, approximately 5 cm in length. Not a current water hazard but should be re-caulked by landlord. Documented as pre-existing. | Confirmed |

Small gap in the caulk line at the tub-to-tile transition near the tap end, approximately 5 cm in length. Not a current water hazard but should be re-caulked by landlord. Documented as pre-existing.

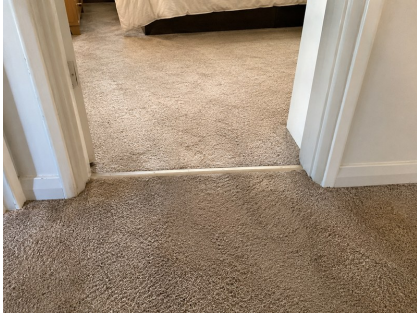
## Bedroom

| Bedroom | Carpet wear at doorway Minor | Visible compression and fibre wear on the carpet at the bedroom doorway, approximately 60 cm × 40 cm zone. Consistent with years of foot traffic. Pre-existing normal wear. | Confirmed |

Visible compression and fibre wear on the carpet at the bedroom doorway, approximately 60 cm × 40 cm zone. Consistent with years of foot traffic. Pre-existing normal wear.

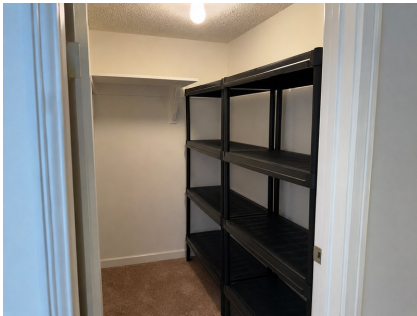
## Storage Room

No visible damage detected in this area. Surfaces and fixtures appear in acceptable condition.
